72 Hours Of Work: Major Corrosive Attack Countered.

Case Study: Paper Mill Wastewater Treatment Clarifier

Project: Clarifier Lining at Blue Heron Paper

Scope: Lining of Wastewater Clarifier with 125 mils of DuraShield 310.

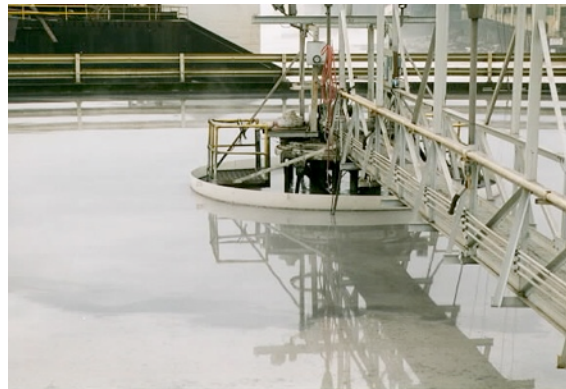
Wastewater Treatment Clarifier
Coated with DuraShield 310

The concrete walls and steel center fill structure were sandblasted and lined with 125 mils and 60 mils of LifeLast DuraShield polyurethane respectively. The work was completed in less than 72 hours. In August 2001 the clarifier was thoroughly inspected and Blue Heron (originally Jefferson Smurfit) found no disbondment or loss of coating throughout the structure. All 10,000 square feet was 100% intact.

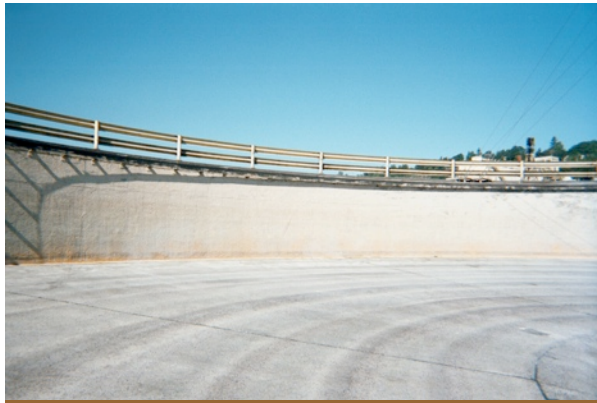
Wastewater Treatment Clarifier Empty During 5 Year Inspection of DuraShield 310 Coating
