Rehab That Stands Up to Harsh Chemical Environments

Case Study: Wastewater Treatment Systems

Project: Concrete Chlorine Basin Lining

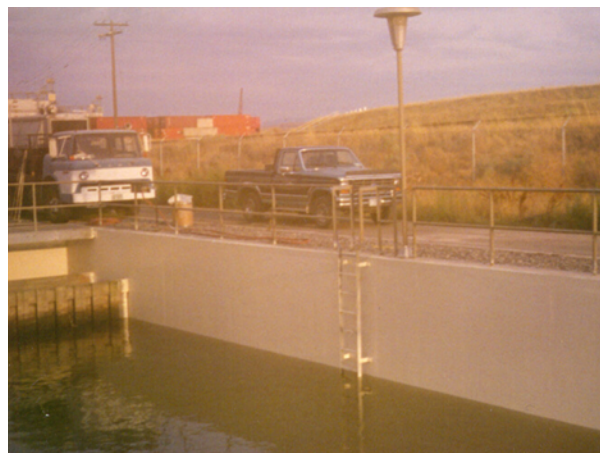
Chlorine Basin After Rehabilitation

The concrete was sandblasted clean, removing all coal tar residual and then lined with 70 mils of LifeLast urethane. In fact, turnaround for the work was less than 72 hours. The lining system was thoroughly inspected in December 1998, and the results showed no loss of coating or disbondment throughout the entire structure.
