Polyurethane Finish: Hatchery Salmon Flourish.

Case Study: Fish Hatchery

Project: The Carson National Fish Hatchery, Carson, WA

Scope: Coating-125 mils of DuraShield 310-61, Fish Hatchery Raceways.

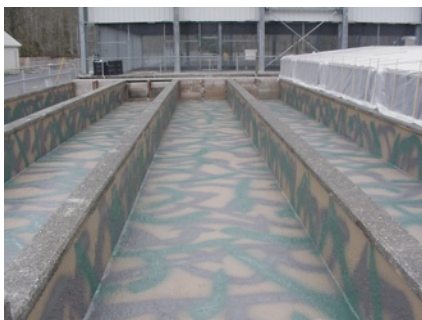
In 2001, the Hatchery was having difficulty cleaning the old fish raceways, which had deteriorated after years of use. Subsequent algae build up and the rough raceway surface was threatening the health of the fish. The need for a repair solution became critical.

Raceway Coated with DuraShield 310-61

A thorough analysis of products and applications was conducted. Ultimately, LifeLast's eco-friendly, 100% solids DuraShield 310-61 polyurethane was selected. A quick cure time and smooth, even surface reduces downtime, minimizes injury to the fish and develops and even surface that is easy to maintain.

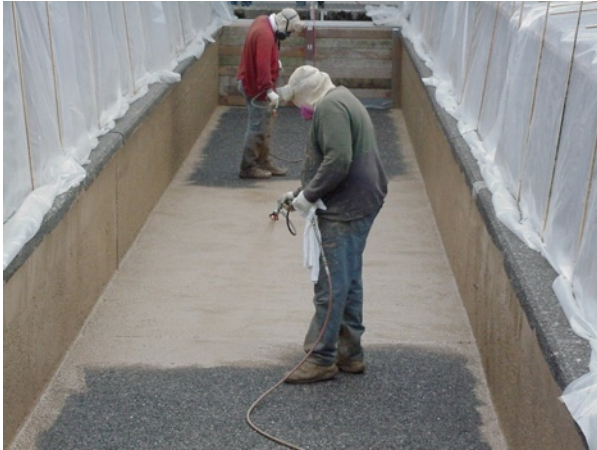
Application of the DuraShield 310-61

The aged, worn, pitted, uneven surface made Carson National Fish Hatchery an ideal candidate for polyurethane coating. In 2002 the surface was steam cleaned to remove residual algae and contaminants, primed and coated with 125 mils of DuraShield 310-61. The preparation and application process are low impact; simple tenting was sufficient to protect surrounding

equipment and tanks. The result is a fish-friendly, cost-effective coating that provides many years of protection.

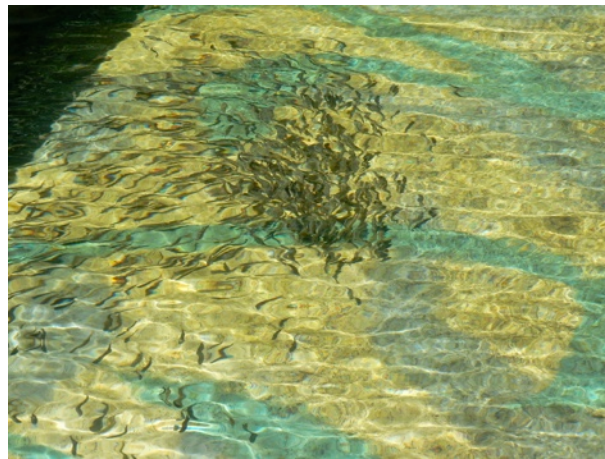
Five years after application, LifeLast made a follow-up site visit to the Carson National Fish Hatchery. The coating was performing flawlessly and the fish population was flourishing. LifeLast continues to partner with hatcheries across the country to provide corrosion and habitat protection systems.

Salmon Fry in Population Five Years After Coating Application
