Aged Penstock Rehabilitation Extends Service Life

Case Study: Hydroelectric Penstock

Project: Long Lake
Hydroelectric Dam Penstock #1
Rehabilitation

Scope: 236' of 16' (192")
Riveted Steel Penstock Pipe with
40-60 mils DuraShield 310-61
NSF Lining

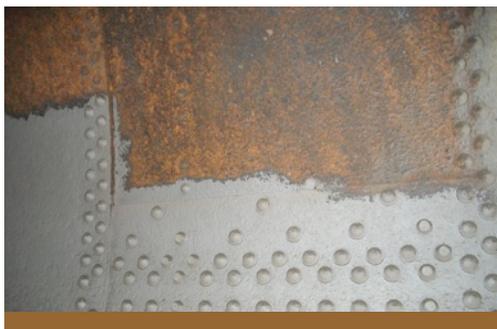
Deteriorating substrate during mechanical blasting

The 99-year old riveted steel penstock hadn't been lined since a 1913 application of coal tar epoxy. Heavy pitting and rust scale were present across the pipe surface. The experienced team from Hancock Sandblasting and Paint achieved the SP10 near white finish required in the application specification. Field conditions presented unique spray conditions, particularly the

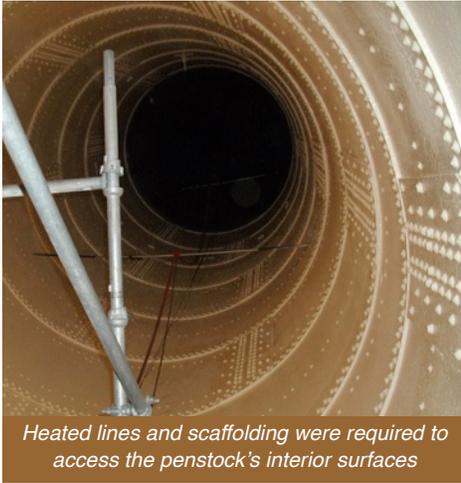
Heated lines and scaffolding were required to access the penstock's interior surfaces

penstock's 38-degree incline with up to 350 feet of heated lines required to access the workspace. The application team wasn't in jeopardy of explosive hazards in the confined workspace deep in the penstock's metallic piping because of DuraShield 310's VOC-free formulation.

The extended pot life of DuraShield 310's two-part polyurethane system saved the Hancock team time and expense by eliminating the need for a separate hand application to address the irregular surface of this challenging environment. Instead, a

crew member was able to ensure adequate coverage by simply following the spray applicator with a brush to wet in the rivets and other irregularities in the penstock surface. This strategy resulted in the specified 40 mils on flat surfaces and 50 to 60 mils elsewhere to ensure rivets were fully encapsulated. Further time and expense was saved in repairs because the polyurethane's proprietary chemistry minimizes pinholes caused by out-gassing.

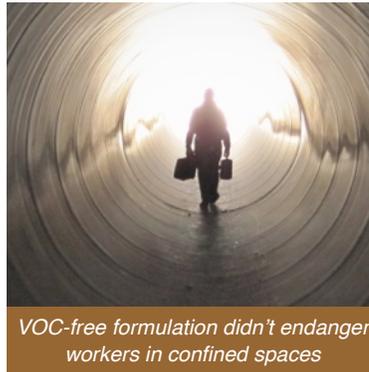
VOC-free formulation didn't endanger workers in confined spaces
