Case Study ▶

DIP Wouldn't Do For The Wastewater Double Wash Crossing.

Case Study: Wastewater Transmission

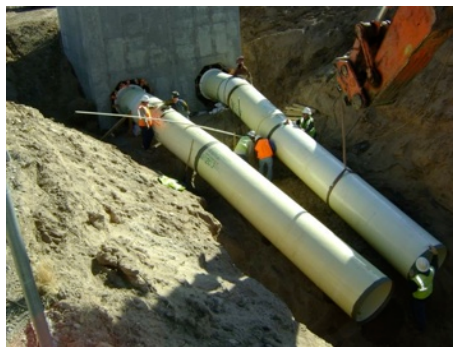
Twin Siphon 42" Welded Steel Pipe with DuraShield 210 Lining and Coating

The engineer conducted a thorough survey of coating and lining options for Ductile Iron Pipe and Welded Steel Pipe using existing standards. Additionally, independent testing for 50% sulfuric acid immersion was analyzed. Finally, a cost comparison of the pipe material and coatings and linings was conducted and in the end, considering LifeLast DuraShield's testing performance, wastewater performance history and a realized savings of \$320,000, Welded Steel Pipe with DuraShield 210 lining and coating was selected. The Northwest Pipe Company, Denver Facility constructed the 42-inch twin siphons and applied DuraShield 210 at 60 mils on the lining and 25 mils on the coating.

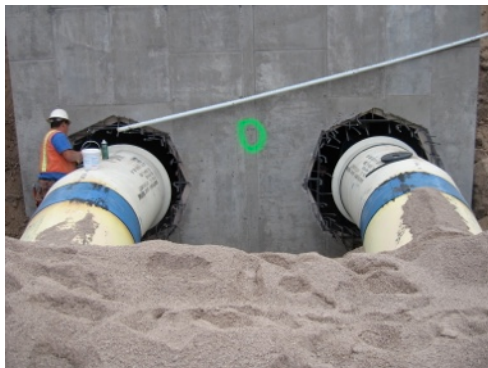
In Field Joint Coating with Heat Shrink Sleeves

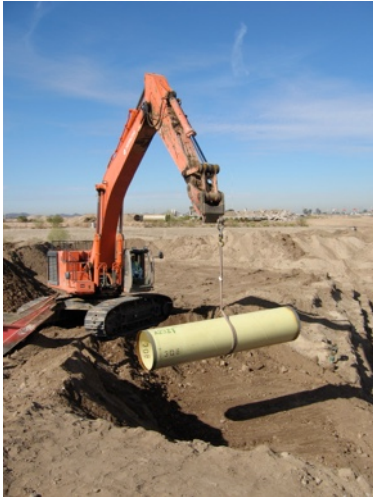
42" Welded Steel Pipe Installation
