## Performance You Can Drag Through the Mud

### Case Study: Horizontal Directional Drilling

**Project:** Skagit River HDD Crossing

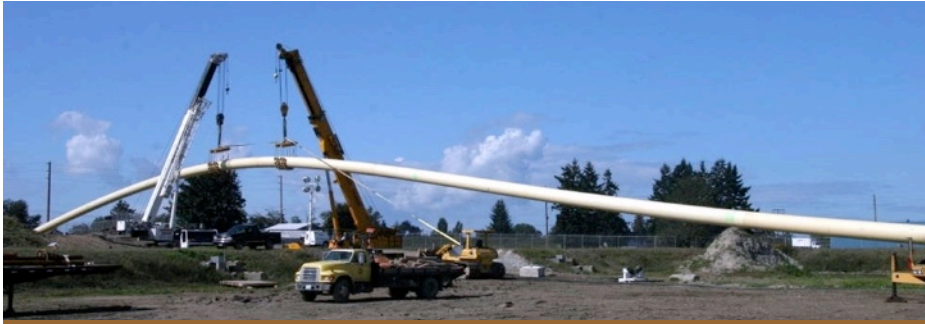
*Crews Strung Preassembled Pipe Lengths Through the Air to Feed into the Drill Pit Hole*

One development since the time the original line was constructed was trenchless technology. Specifically, the practice of horizontal directional drilling allowed the City to select a route that went under two local rivers. Segment 5/6 of the project included a 3.2 mile transmission line running from their water treatment plant, adjacent to the Skagit River, to Fidalgo and Whidbey Islands by pulling 1,540 lineal feet of pipe 45 feet below the river bottom. To accomplish this feat, the contractor preassembled long lengths of the flexible polyurethane-coated steel pipes in a staging area and then drugged them through a hole created using progressively larger boring heads to tunnel a route for the pipeline to pass through. The largest bore was a 54” head, which created space to uniformly inject bitumen grout around the 36” pipe length as it

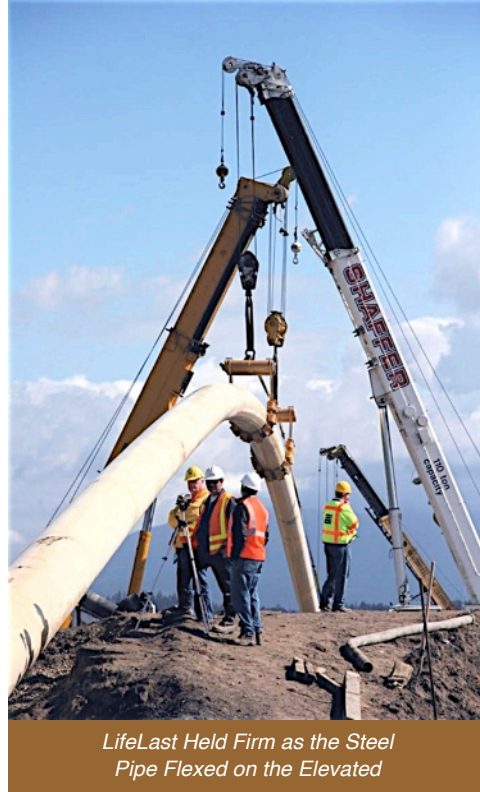
*LifeLast Held Firm as the Steel Pipe Flexed on the Elevated*

was pulled through. The pipe forces during the pull reached 300,000 pounds. Sixty mils of interior and exterior LifeLast DuraShield 210 polyurethane stuck with the flexing pipe lengths throughout the installation thanks to its strong adhesion properties. Its high abrasion resistance qualities ensured the pipelines would remain cathodically and mechanically protected from the surrounding soil chemistry.
