Returning Aging Assets to Efficient Performers

Case Study: Wastewater Treatment Systems

Project: KapStone Paper UNOX Basin Lining

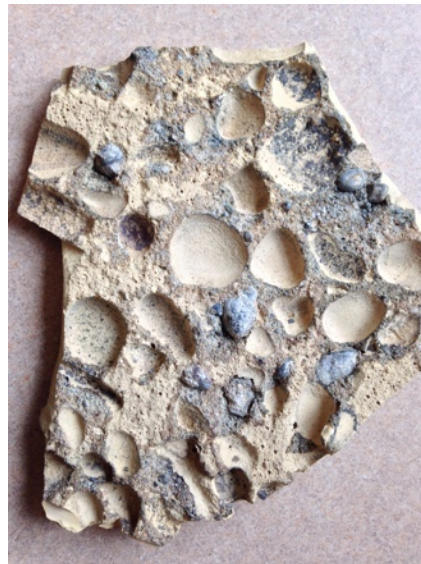
11-Year Inspection Sample

The concrete was sandblasted clean and then lined with 80+ mils of LifeLast urethane. In fact, turnaround for the entire project was less than 72 hours due in large part to the DuraShield's high build properties and fast cure times. The lining system was thoroughly inspected in 2001 and the results showed no loss of coating or disbondment throughout the entire structure, all 100,000+ ft² was 100% intact.
